JACOBS ENGINEERING GROUP INC.

April 5, 1995

Final Site Inspection Prioritization Report for the Deer Valley Site Florissant, Missouri CERCLIS No. MOD981712011 EPA Work Assignment No. 53-7JZZ Jacobs Project No. 12-D253-40

FINAL
SITE INSPECTION PRIORITIZATION REPORT
FOR THE
DEER VALLEY SITE
FLORISSANT, MISSOURI
CERCLIS NO. MOD981712011

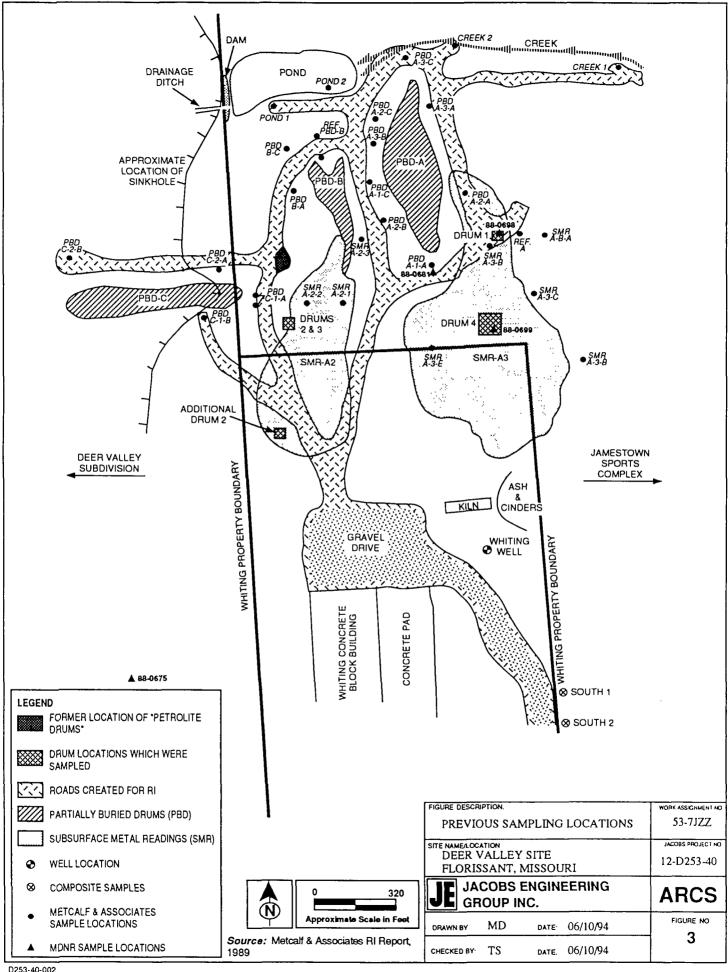
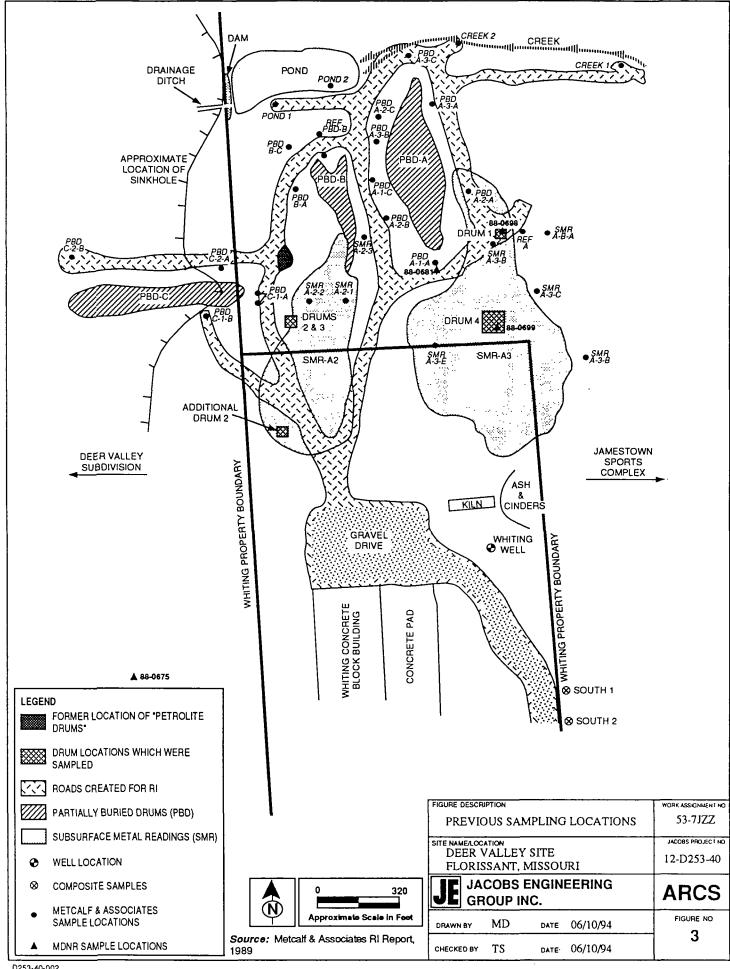
Additional observations by MDNR during the December 1986 investigation indicated an old brick kiln structure (lined inside with concrete), about 100 feet east-northeast of the Whiting building (Figure 2), possibly used by previous occupants to incinerate residues in the drum reconditioning business. Ashes and cinders were observed by MDNR adjacent to the kiln on the south and east sides, along with a few drum heads.

Additional observations by MDNR during the December 1986 investigation indicated an old brick kiln structure (lined inside with concrete), about 100 feet east-northeast of the Whiting building (Figure 2), possibly used by previous occupants to incinerate residues in the drum reconditioning business. Ashes and cinders were observed by MDNR adjacent to the kiln on the south and east sides, along with a few drum heads (Reference 1).
